RANDOM MISFIRE

The Quarterly E-Newsletter for the Automotive Repair Industry

O2'S, FUEL TRIMS AND LOOP STATUS

The vehicle I am using for this issue's example is a 2000 Sable with a 3.0 liter engine. The customer's complaint is runs rough and MIL flashing. A quick check of codes reveals a P0302—misfire detected cylinder number 2.

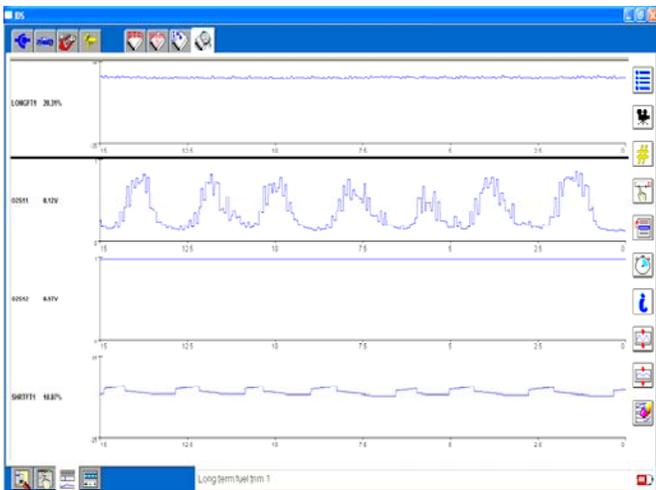
With trims being skewed I have 2 options. I can adjust for the correction which still pints me in the direction of an ignition misfire. Or I can move to my next indicator... downstream oxygen sensor readings. In the capture below you can see my downstream O2 sensor reads high. Yet another indicator of an ignition issue.

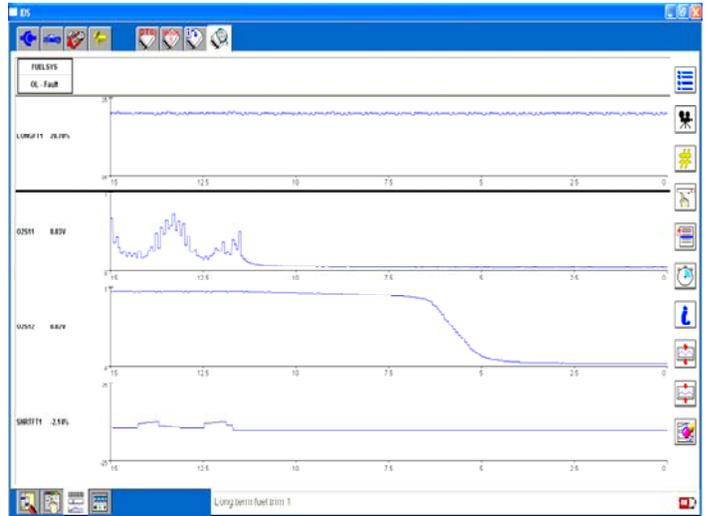
The data obviously changed. However, the vehicle still feels like it is running exactly the same... one dead cylinder. What happened?

My downstream O2 sensor flat lines lean. If I had happened to use my downstream O2 for diagnosis when this condition was occurring it would have lead me towards a fuel issue. This is a case where loop status (or the Fuel Sys PID here) needs to be paid attention to. If you notice in the upper left corner of the screen the Fuel Sys PID reads: OL—Fault. Simple enough, the PCM went into open loop because of the misfire. But, why did the downstream O2 sensor go so lean? Is the PCM not reporting accurately? Or did the engine actually start running very lean?

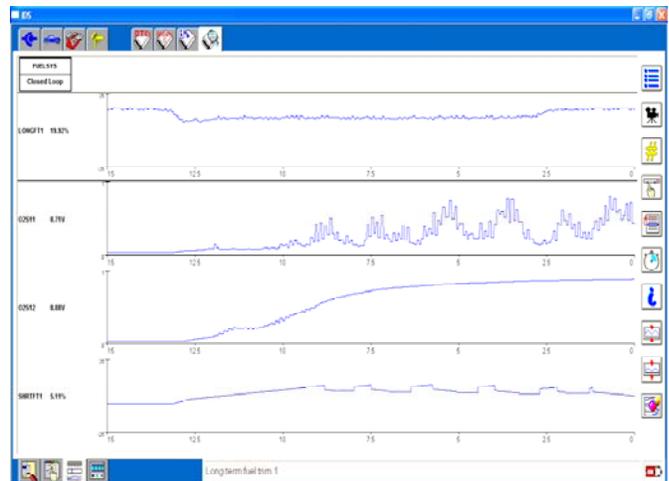
If we leave the vehicle run for a while it switches back to closed loop.

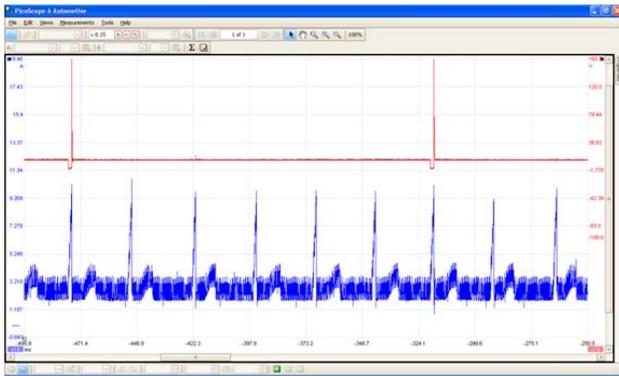
Here is a capture of closed loop operation on a scope. Please excuse the noise in the capture, but it should still be sufficient to get my point across.

The high spikes are the current ramps from the ignition coils. The 6 smaller ramps are the current being drawn by the fuel injectors.

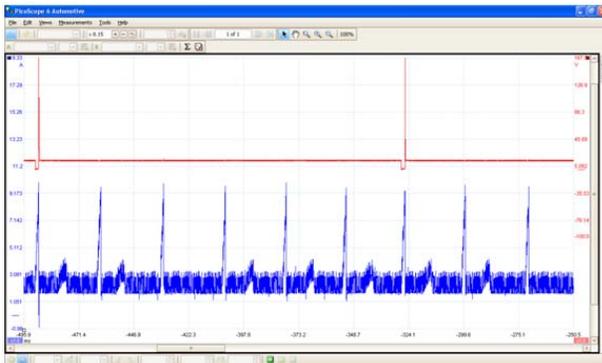
Notice that the current ramp for the number 2 fuel injector is missing. This is normal operation for this open loop fault mode. The PCM will continue to switch back and forth between the 2 modes.

Remember... the PCM does not know if the misfire is being caused by a fuel, ignition or mechanical issue. The PCM only knows that there is a misfire. Therefore, the misfire does not change when the injector is disabled. There is no difference in how the car feels when you drive it. But this strategy is the best way for the PCM to protect the catalyst.

This vehicle did in fact have an ignition misfire. The problem was resolved and the misfire went away.

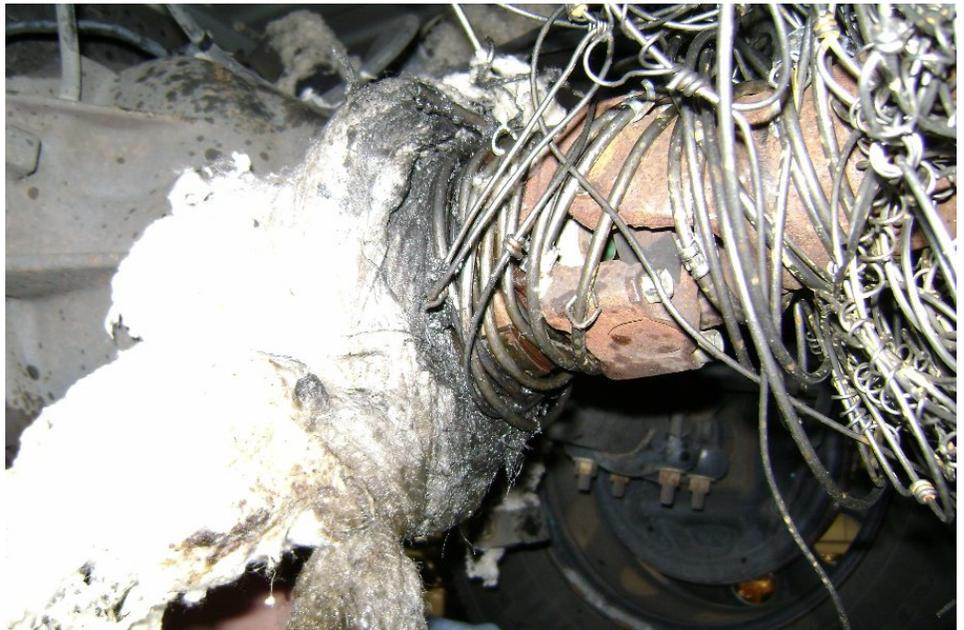
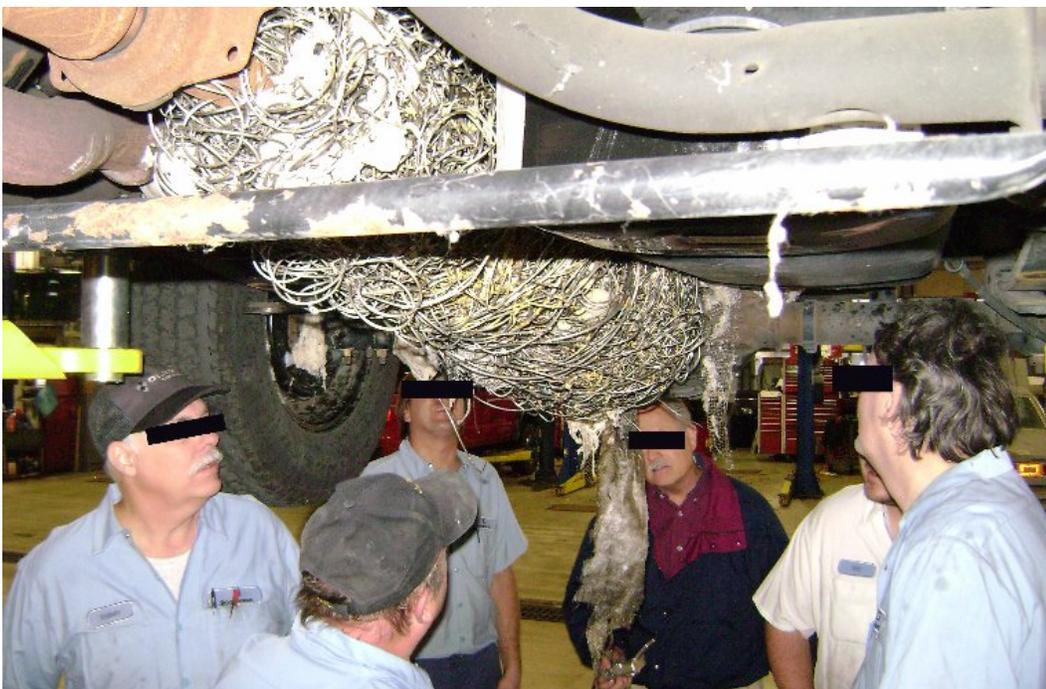
Anyway, someone ran over a mattress and just kept going. Apparently they managed to go 30 miles or so before the springs ripped a hole in the gas tank.

So the vibration did not stop the customer, but the lack of fuel did.

The customer, did however, complain of a shimmy at highway speeds when the vehicle was

brought into the shop. Imagine that! I wonder what could have possibly caused this mysterious shimmy?
