RANDOM MISFIRE

The Quarterly E-Newsletter for the Automotive Repair Industry

O2'S, FUEL TRIMS AND LOOP STATUS

The vehicle I am using for this issue's example is a 2000 Sable with a 3.0 liter engine. The customer's complaint is runs rough and MIL flashing. A quick check of codes reveals a P0302—misfire detected cylinder number 2.

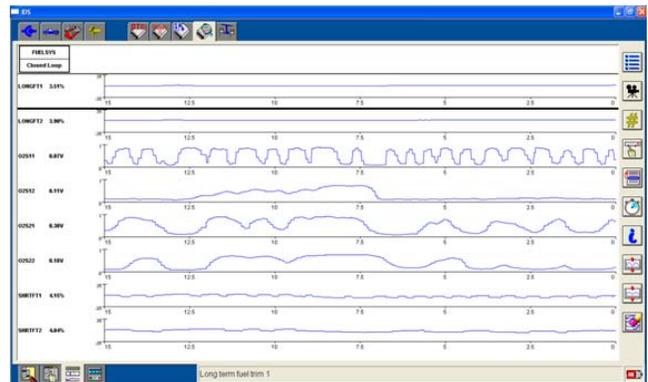
under idle conditions. When the engine was brought up to around 2500 RPMs the total trim numbers neared zero. This indicated to me that a vacuum leak was the most likely cause. It also explained why the fuel trim numbers stored in the freeze frame were not extremely positive. The freeze frame was stored at 2490 RPM, much like the conditions I created in the bay when my trim numbers came back down.

This Sable did in fact have a vacuum leak. Another quick repair and multiple problems solved!

Final thought... do you see a slow B2S1 and a catalytic converter in the near future?
